CHISANA

HISTORIC STRUCTURE REPORT

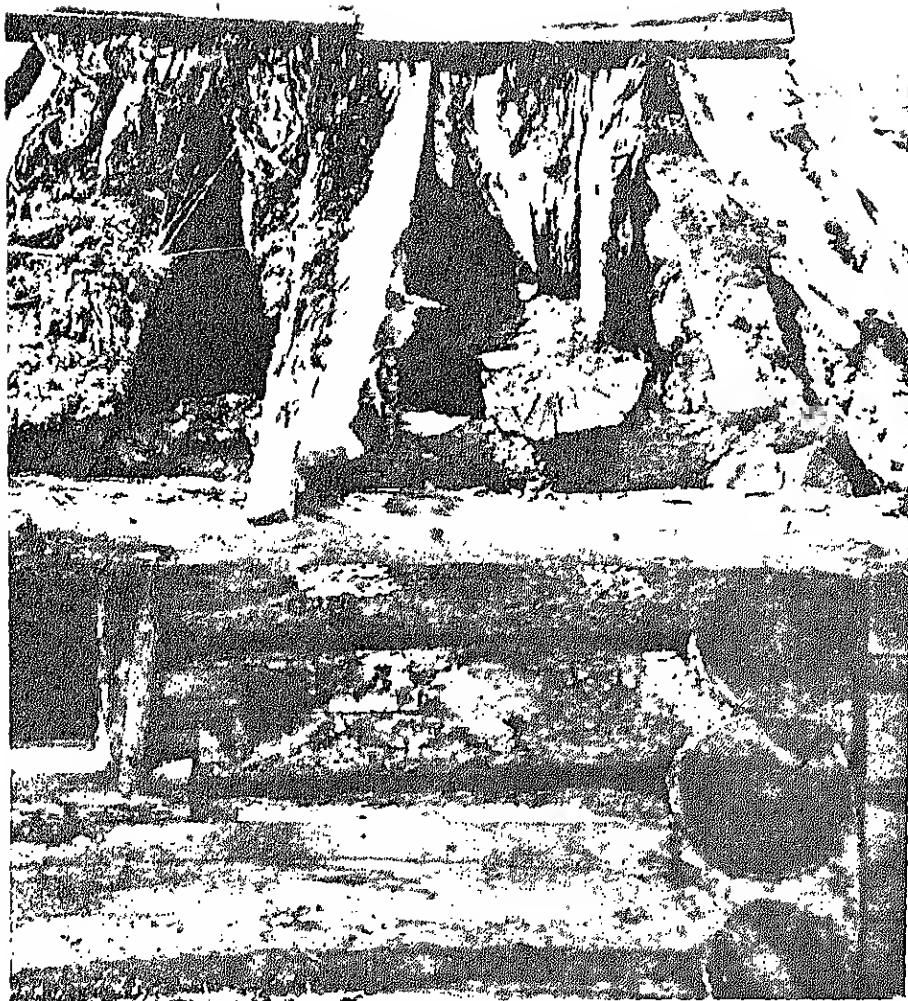
Photograph 6
Women's Jail, Chisana
"Hole-in-Roof" Detail, South Side.

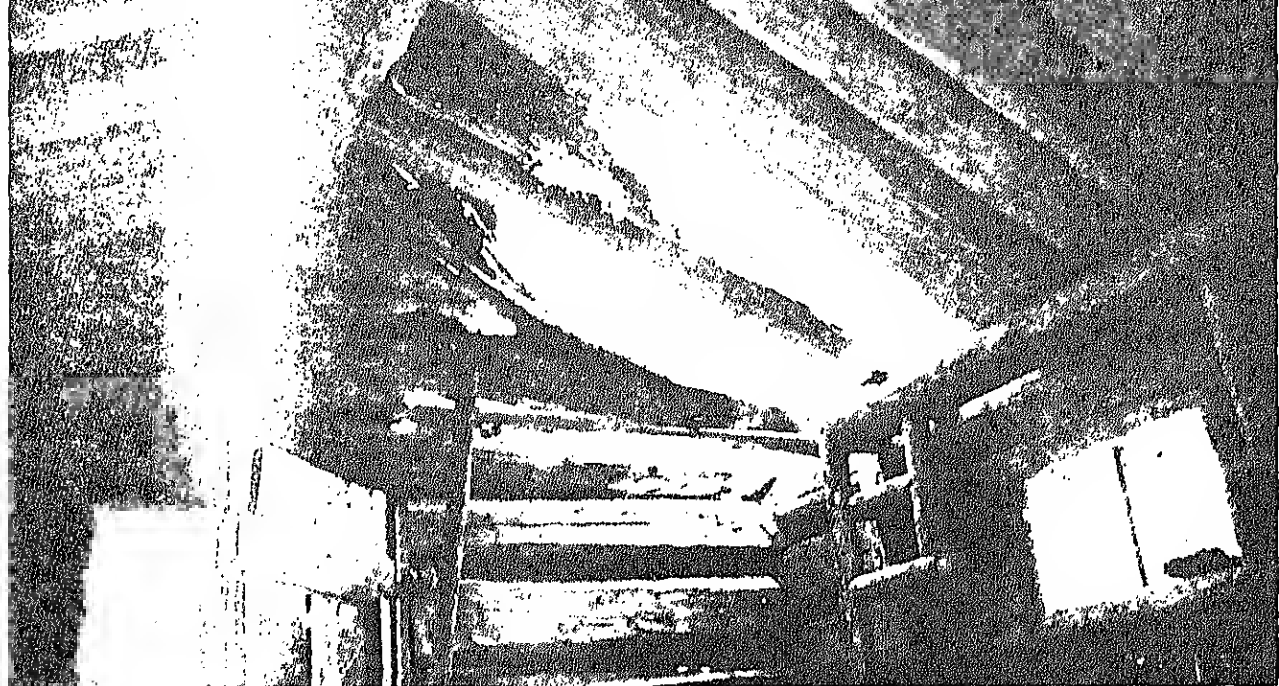
Photograph 7
Women's Jail, Chisana
Collapsed Ceiling, South Side.

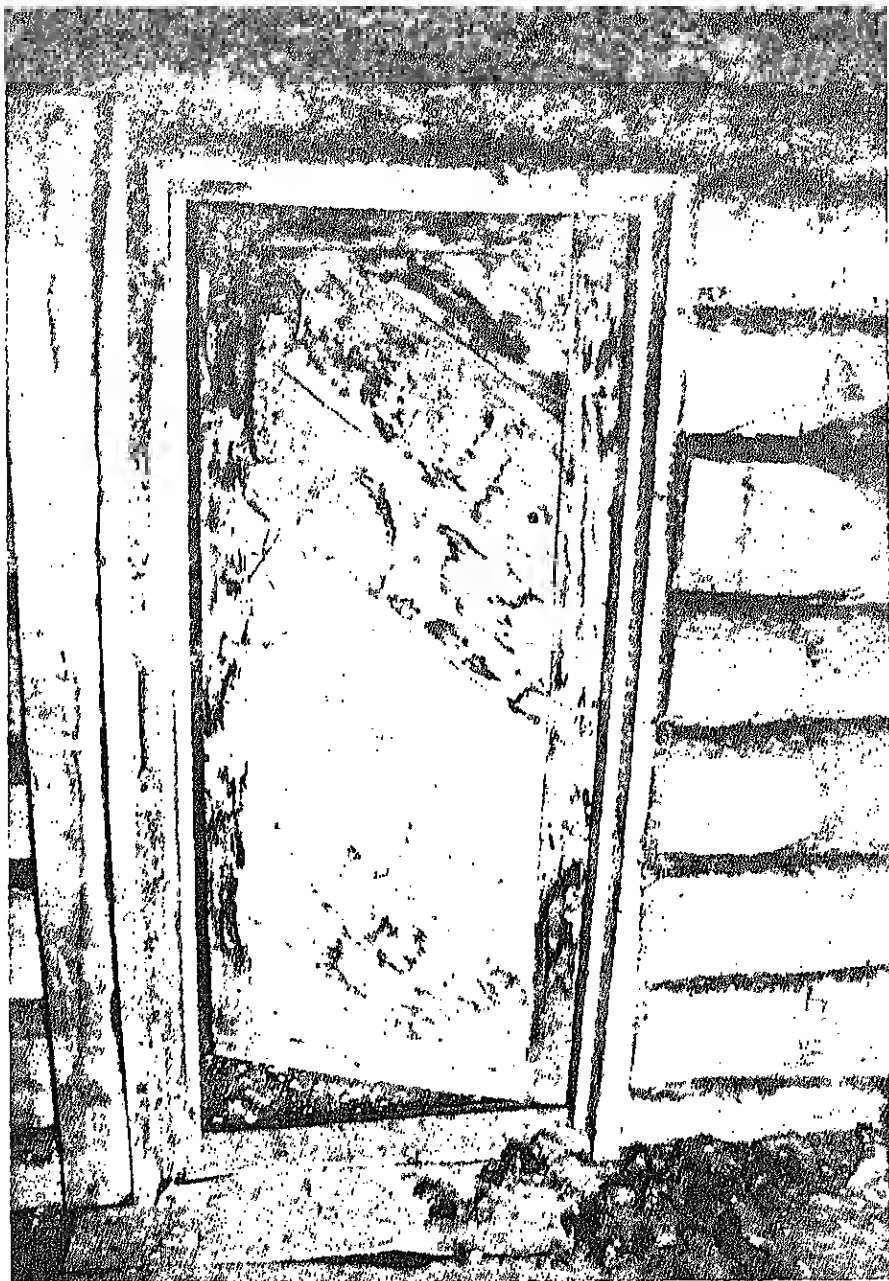
Photograph 23

U.S. Commissioner's Court, Chisana
Front entry to main cabin with hewn
logs at trim; trim missing on
right side.

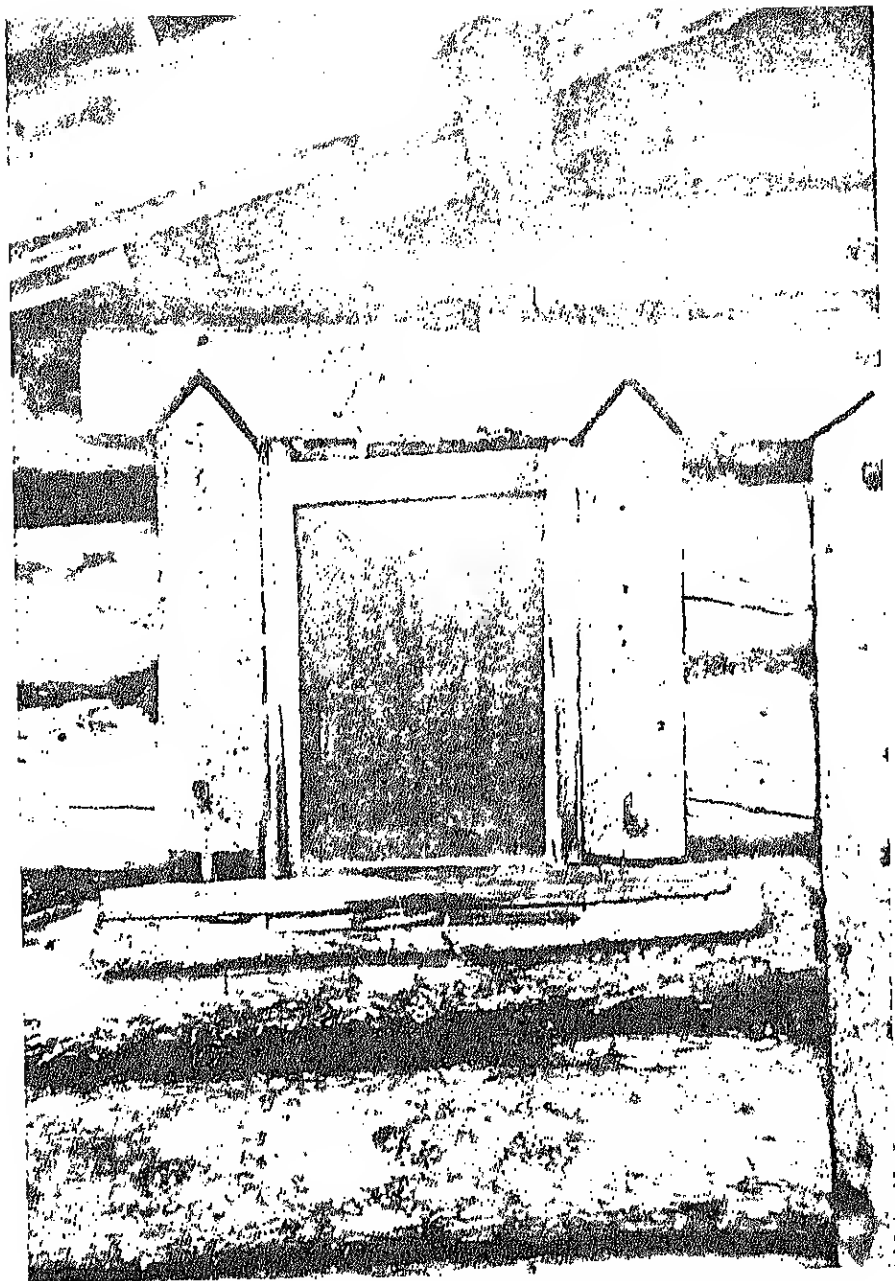
Photograph 42

Front window with racked frame and
seperating trim (note pegs nolding trim
in place).
